2 Mb/s (E1) G.703 / ASI Network Interface Adapter

User Manual

This instruction book applies to units fitted with firmware version mdc3661i2.

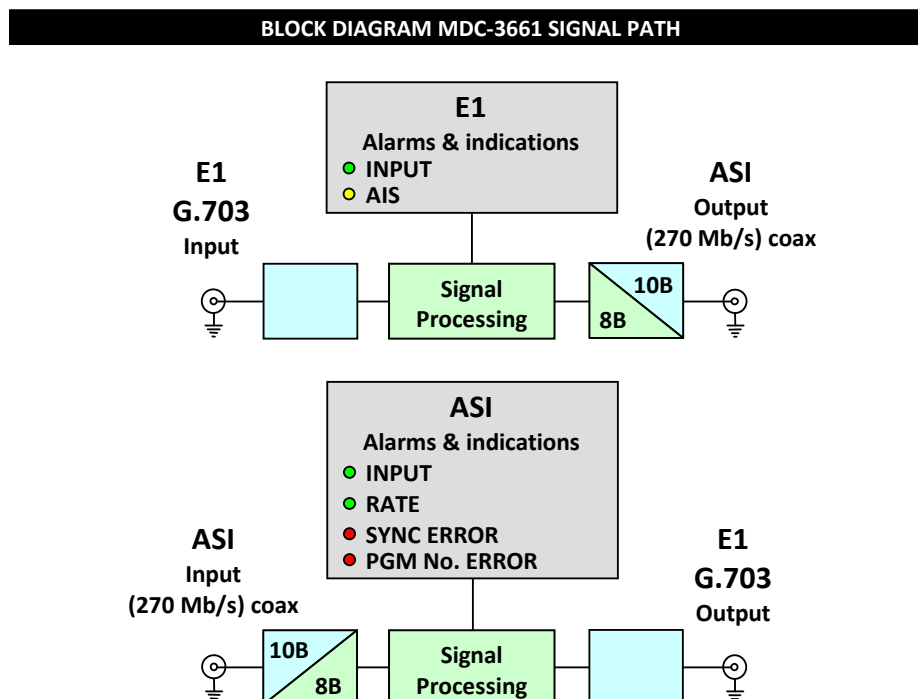
The MDC-3661 takes a 2048 kb/s G.703 (E1) signal and packs it as private data into a DVB compliant, 188 or 204 byte (selectable), ASI transport stream. On board switch settings set the ASI program number to a choice of 8 settings. This allows it to pass through ASI style of circuits such as IRT's ASI Mux/DeMux and fibre modules as well as ASI statistical multiplexers.

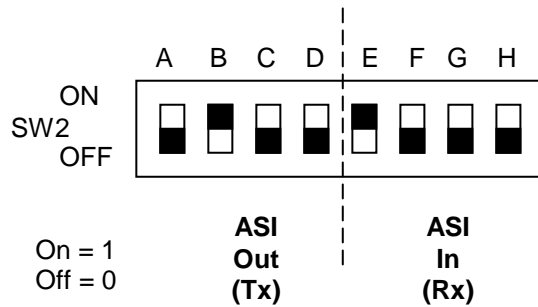
ASI Program Number set:

Switch 2 sets a choice of 8 different program numbers for both the ASI output and the ASI input.

SW2-A OFF - 204 byte ASI output at 3.072 Mb/s;
ON - 188 byte ASI output at 2.831 Mb/s.

SW2-E - Not Used.
